CASE REPORT

A Shot Through the Window

REFERENCE: Burnett BR. A shot through the window. *J Forensic Sci* 2001;46(2):379–385.

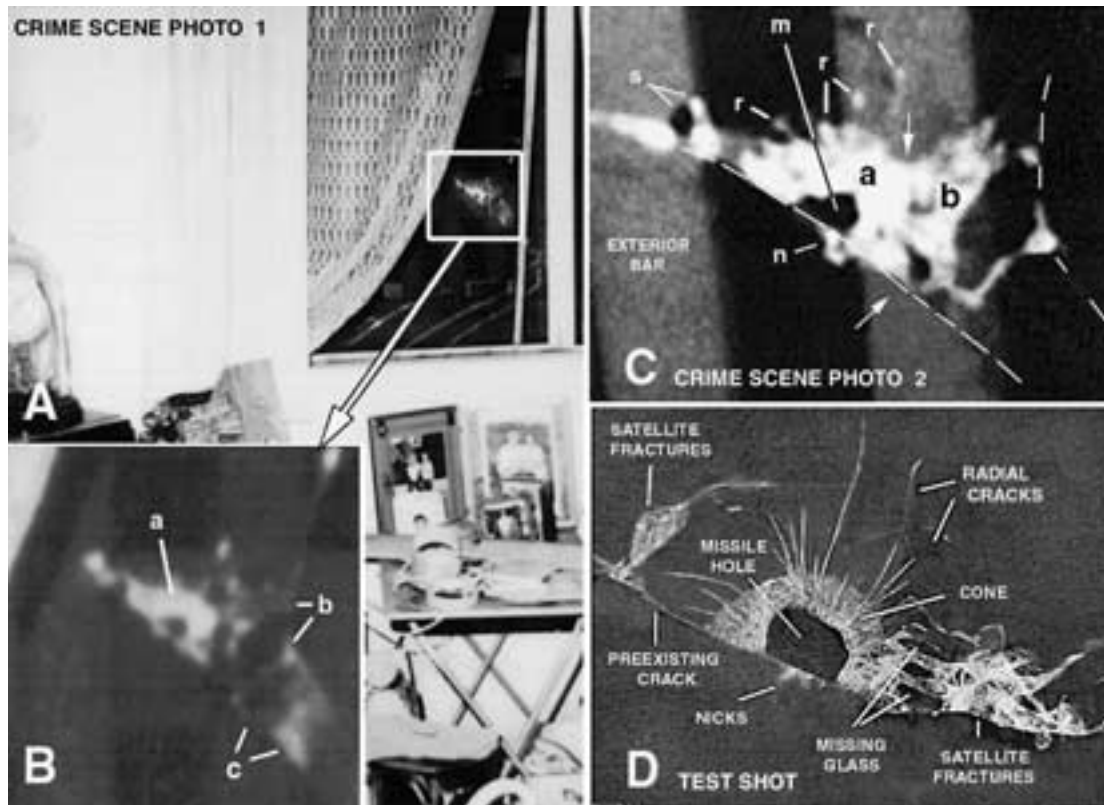
FIG. 1—A: One of the two crime scene photographs that show the questioned window defect. The thin bar to the right of the defect is part of the window screen frame. To the right of the screen frame is the center bar of the window. B: Enlargement of the defect in the window shown in A. (a) Region corresponding to the cone produced by a bullet. (b) Possible area of satellite fracturing. (c) Possible area of satellite fracturing that was apparently lost before the second photograph was taken. C: Enlargement of the crime scene window defect taken from the second of the two photographs that showed the defect. There was an outside decorative wooden grillwork approximately 12 in. (30 cm) from the window, two bars of which can be seen in the photograph. Dashed lines represent apparent preexisting cracks in the window. (a) Region corresponding to the cone produced by a bullet. (b) Possible area of satellite fracturing. “m” Apparent bullet hole. “n” Possible nicks. “r” Possible radial cracks. The arrows mark the border between regions (a) and (b). D: Image of one of the test shots through the previously cracked window. A small portion of the glass to the left of the bullet hole along the preexisting crack fell from the defect and was digitally reconstructed. The bullet hole in this defect is larger than those produced by the other test shots. This defect was selected because of the extensive satellite fracturing.

The other shots in this experiment series produced a defect on only one side of the window crack. The cone and radial cracks did not transmit to the glass on the other side of the crack, producing a “rising sun” defect (e.g., Fig. 1D). This feature was created when the bullet hit only or mostly (see below) on one side of the glass near the crack. This is the situation that appears to have occurred for the crime scene window defect, where the presumed .22 bullet struck mostly above a preexisting crack in the window. One of the test defects (Fig. 1D) closely resembles the crime scene window defect.

In the crime scene window, the area marked “a” (Figs. 1B and 1C) corresponds to the cone region in the test window defect (Fig. 1D) and the radial cracks correspond to apparent radial cracks (“r” in Fig. 1C) in the questioned window defect. In addition, there are small nicks in the test window defect (Fig. 1D) below the preexisting crack near the bullet strike hole. The crime scene window defect shows similar apparent nicks (“n” in Fig. 1C). Satellite fractures occur in several of the test shots (e.g., Fig. 1D). These areas are found a short distance from the cone and have extensive fracturing within a confined area. The area of the satellite fractures may

be relatively small (Fig. 1D, left) to fairly large (Fig. 1D, right). Some loss of glass may occur within the area of the satellite fractures at the time of the shot. It appears that in the crime scene window region “b” (Figs. 1B and 1C) is a satellite fracture area. There is likely an additional, smaller satellite fracture area to the left of the cone area (“s” in Fig. 1C).

The area of the questioned window corresponding to region “b” in the crime scene photograph (Fig. 1B) has a different appearance than that same region in the second crime scene photograph (Fig. 1C). The reason for the difference between the two photographs may be that depending on the camera and flash angle, satellite fractures reflect light back to the camera differently between photographs due to the angles of the fractures in the glass. A portion of the satellite fracture area in the lower right part of the first photograph of the crime scene window (“c” in Fig. 1B) does not appear in the second photograph of the crime scene window (Fig. 1C). Pieces of the defect likely fell from the window during the time between the two photographs.

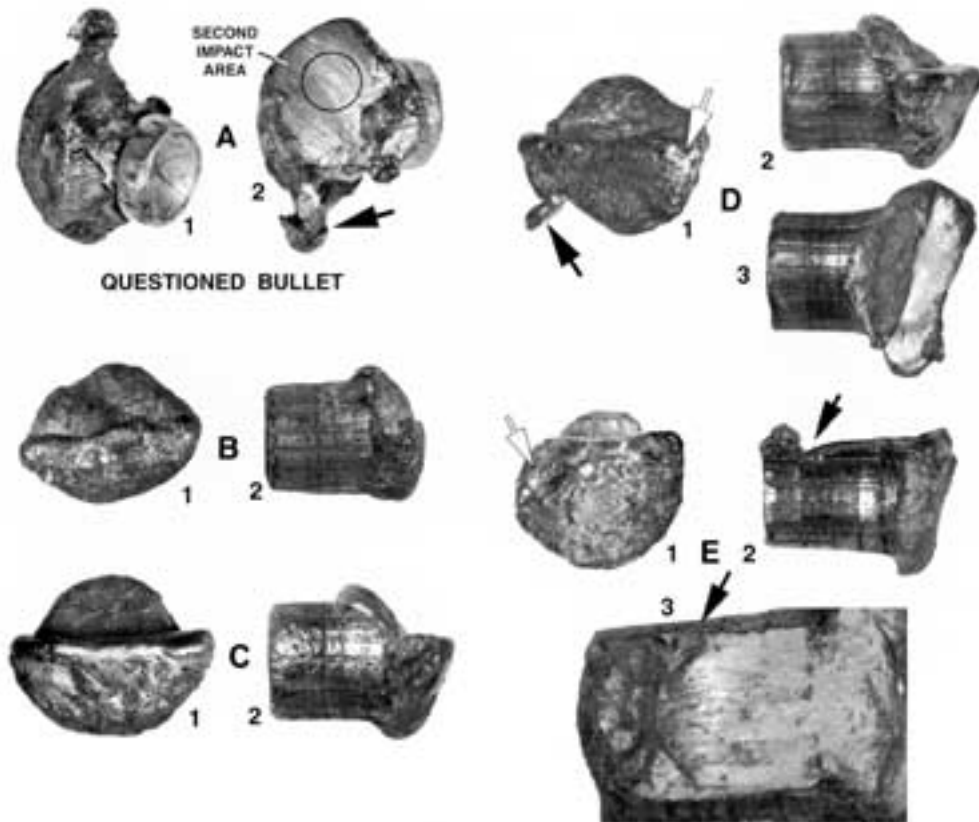
The medical examiner testified that the bullet entrance hole in the victim appeared to be from a larger caliber (i.e., the bullet was likely mushroomed prior to striking the victim). It also appeared that the .22 missile had hit a second object after mushroom formation in that there is a scrape mark on the mushroom of the bullet (Fig. 2A-2).

Some of the test .22 bullets show the result of striking a window crack near the center of the bullet (Figs. 2B, 2C, and 2D). The breakage of the glass on one side of a crack before the other may result in a "step" feature in the mushroom of the bullet as shown in some of the test bullets (Figs. 2B, 2C, and 2D). These features on the bullets make it clear that one side of the glass on a crack is often more resistant to failure than the other. Usually, when the glass fails on one side of a crack, it goes all at once. However, a nonuniform failure may have occurred for the bullet shown in Fig. 2D in that this bullet rotated approximately 20° from center (Fig. 2D-3) before the first side of the glass on the crack failed. The second side of the glass failed with the bullet remaining at approximately the same angle.

Another of the test bullets (Fig. 2E) showed a particularly interesting result of a strike near the edge of the bullet at a window crack. For this bullet, as in the bullets shown in Figs. 2B, 2C, and 2D, the glass on one side of the crack failed before the other. However, in this case the bullet did not break free of the unbroken side of the glass until the bullet was scraped almost its entire length by

the glass edge. Near the base of the bullet, the gouging by the glass edge deepened into the bullet (Fig. 2E-2, arrow) which apparently resulted in the glass edge breaking before the bullet was clear of the glass. Tool-mark-like striae are present (Fig. 2E-3, arrow). Most likely the scrape marks on the anterior portion of this test bullet were almost completely obliterated from friction by the cotton fibers of the bullet collection box.

FIG. 2—A: The .22 bullet taken from the victim at autopsy. Circle: area examined by SEM/EDS. Arrow: lead spur. B: Test .22 bullet that was shot through window glass at a crack. C: Test .22 bullet that was shot through window glass at a crack. D: Test .22 bullet that was shot through window glass at a crack. White arrow (on D-1) points to a concentration of powdered glass. Black arrow (on D-1) points to a lead spur. The bullet shown in D-2 is rotated 90° in D-3. E: Test .22 bullet that was shot through window glass at a crack. White arrow (on E-1) points to a concentration of powdered glass. Black arrows (on E-2 and E-3) indicate a dip in the gouge into the bullet body caused by the window glass. The scrape area of bullet shown in E-2 was rotated 90° and enlarged in E-3.

The morphology of the test bullets that had interacted with the cracked window glass provides an explanation for the second apparent impact on the victim's bullet. Like the test bullet shown in Fig. 2E, the interaction of the victim's bullet with cracked window glass created the appearance of a second impact area on that bullet. Fragments of glass were embedded in the second impact surface of the bullet, either from the glass edge that scraped the bullet or glass particles were transported from the mushroom area. Unlike the test bullet shown in Fig. 2E, a smaller portion of the victim's bullet overlapped one side of the crack. When the side of the glass failed where most of the victim's bullet hit, the unbroken glass on the other side of the crack (Figs. 1B and 1C) provided the scraping surface to produce the appearance of a second impact on the bullet. The second strike of the victim's bullet was at approximately 45° to the first. Although none of the test bullets rotated this much, the test bullet shown in Fig. 2D rotated approximately 20° on the glass before the first side failed, thus showing that a .22 bullet can rotate during a strike on glass.

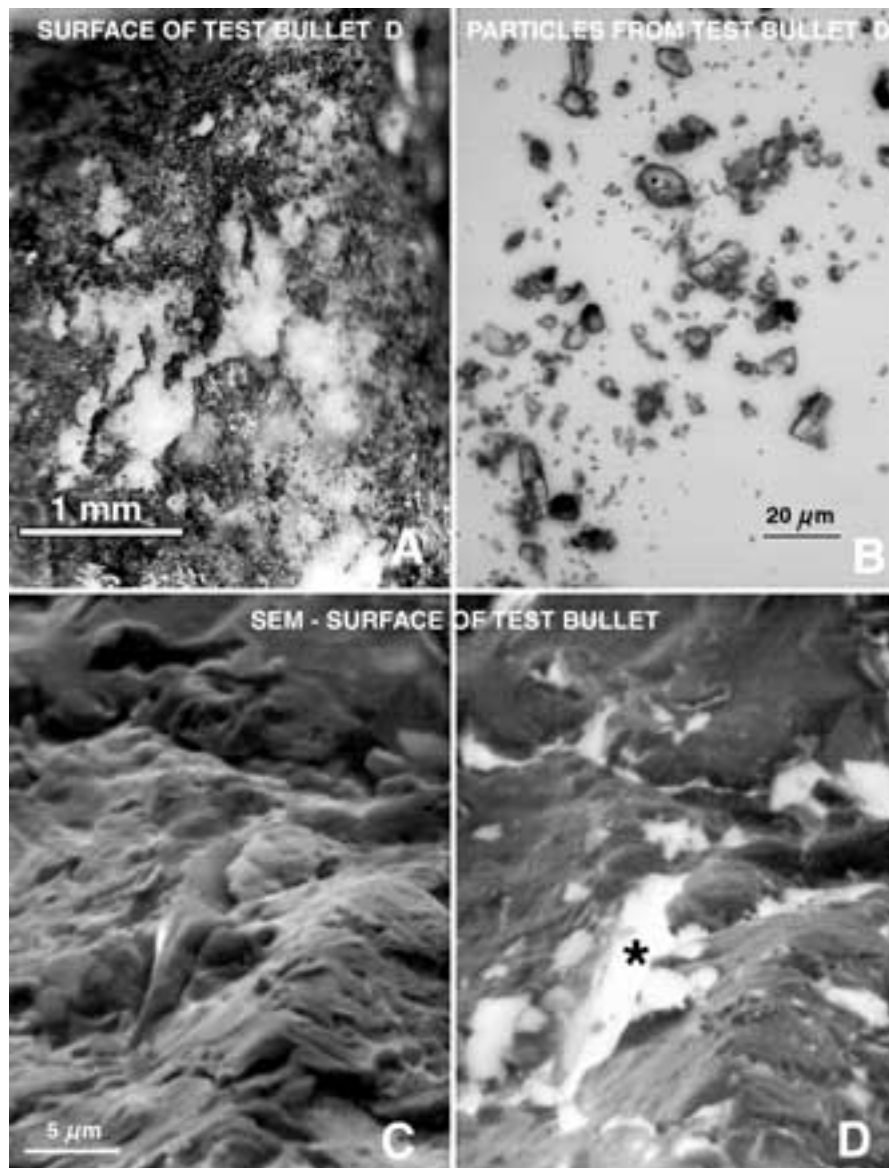
In the test shots through the window, the mushroomed surfaces of many of these bullets show regions of white powder (Fig. 2D-1, white arrow; Fig. 2E-1, white arrow, and Fig. 3A). Particle sizes range from less than 0.5 to almost 20 μm (Fig. 3B). Analysis by EDS reveals these particles to have the same composition as that of the test window glass (see Fig. 5C). Scanning electron microscopical examination of one of the mushroomed test bullet's surface shows the fragments of glass (Figs. 3C and 3D), some of which are embedded in the bullet's lead surface (e.g., Fig. 3D, asterisk).

FIG. 3—Observations of the bullet and associated particles from the test window shots. A: A concentration of powdered glass from an area on a test bullet. Even at a magnification of $70\times$ through a stereomicroscope, individual glass particles could not be resolved. B: A portion of the sample from the powder that was spread onto a slide and imaged through a compound microscope. By SEM/EDS, these same particles were identified as window glass. C: Scanning electron microscope—secondary electron image of the surface of a test .22 bullet that was shot through a window. D: The same area and magnification as 3C, but a reverse backscatter electron image. The white features (low backscattering relative to the bullet's lead surface) are glass fragments, one of which is embedded (asterisk) in the lead.

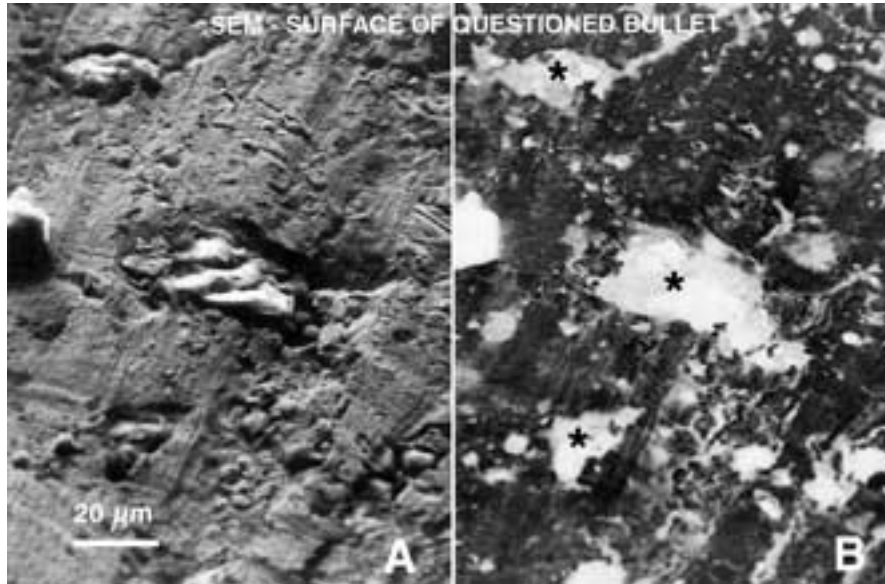
bedded in the bullet's lead surface (Figs. 4A and 4B). Spectra (e.g., Fig. 5A) taken of these particles show that they have essentially the same composition as that of the window glass fragment found at the crime scene (Fig. 5B). Glass from both the test window and the crime scene window have similar compositions (Figs. 5B and 5C). Comparison of a spectrum of a glass particle embedded in a test bullet (Fig. 5D) with a particle embedded in the victim's bullet (Fig. 5A), also show a close similarity. It is likely that the embedded particles in the victim's bullet are from the crime scene window glass.

FIG. 4—Scanning electron microscopy of the .22 bullet from the victim in the region of the second impact zone (within the black circle in Fig. 2A). A: Secondary electron image. B: The same area as A, but a reverse backscatter electron image. The white features (low backscattering relative to the bullet surface) appear to be glass fragments and tissue debris. The apparent glass fragments (asterisks) are embedded in the surface of the lead.

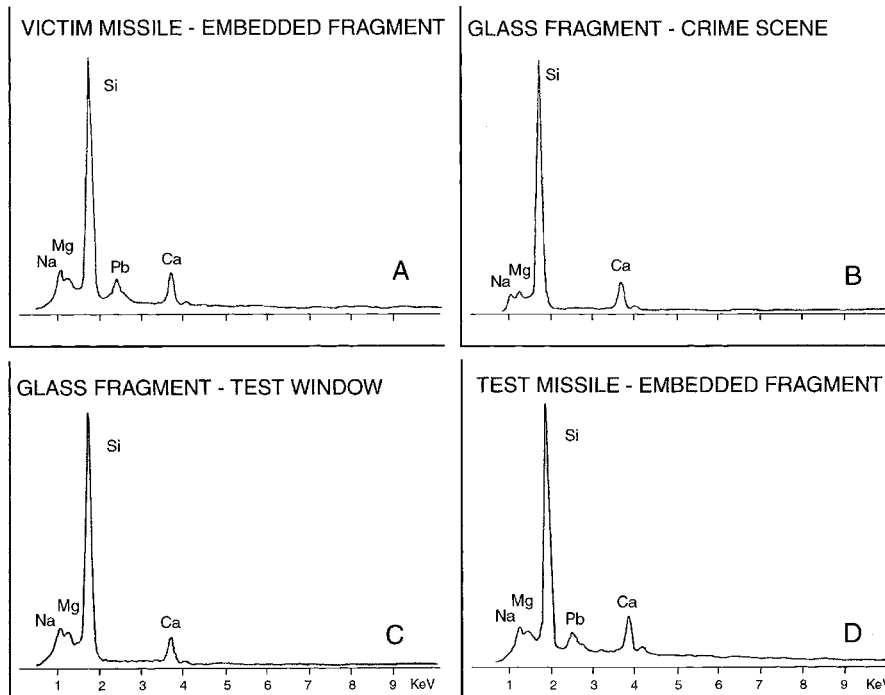
FIG. 5—Energy dispersive X-ray spectra. A: Spectrum of an apparent embedded glass fragment from the victim's bullet. B: Spectrum of a glass fragment recovered from near the crime scene window. C: Spectrum of a glass fragment from the test window. D: Spectrum of an embedded glass fragment from a test bullet.

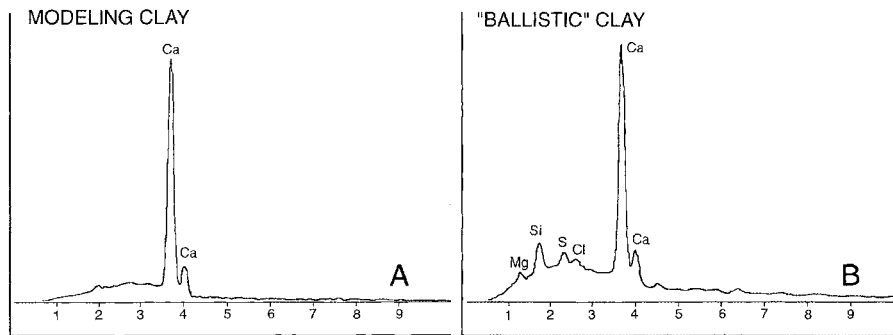
Three recently purchased (ca. 1996) samples of modeling clay, one of which was used for bullet mounting in a comparison microscope in the author's laboratory, were analyzed in the scanning electron microscope with a beryllium-window energy dispersive X-ray analyzer. All these samples showed calcium without other elements (Fig. 6A). Four samples of a clay-like substance found in

the metal bullet mounts of an approximately 50-year-old B&L comparison microscope all showed varying amounts of silicon and magnesium (likely talc), sulfur, chlorine, and calcium (e.g., Fig. 6B). Calcium predominates in all of these samples. There is no similarity between the spectra of window glass (e.g., Fig. 5B) and that of any of the clay and clay-like samples.

FIG. 6—Energy dispersive X-ray spectra. A: Spectrum of a cream-colored modeling clay used for bullet mounting in the Forensic Science Consulting Group's laboratory, Cardiff, California, 1996 through 1998. B: Spectrum of a clay-like substance found in the metal bullet mounts of an approximately 50-year-old B&L comparison microscope.

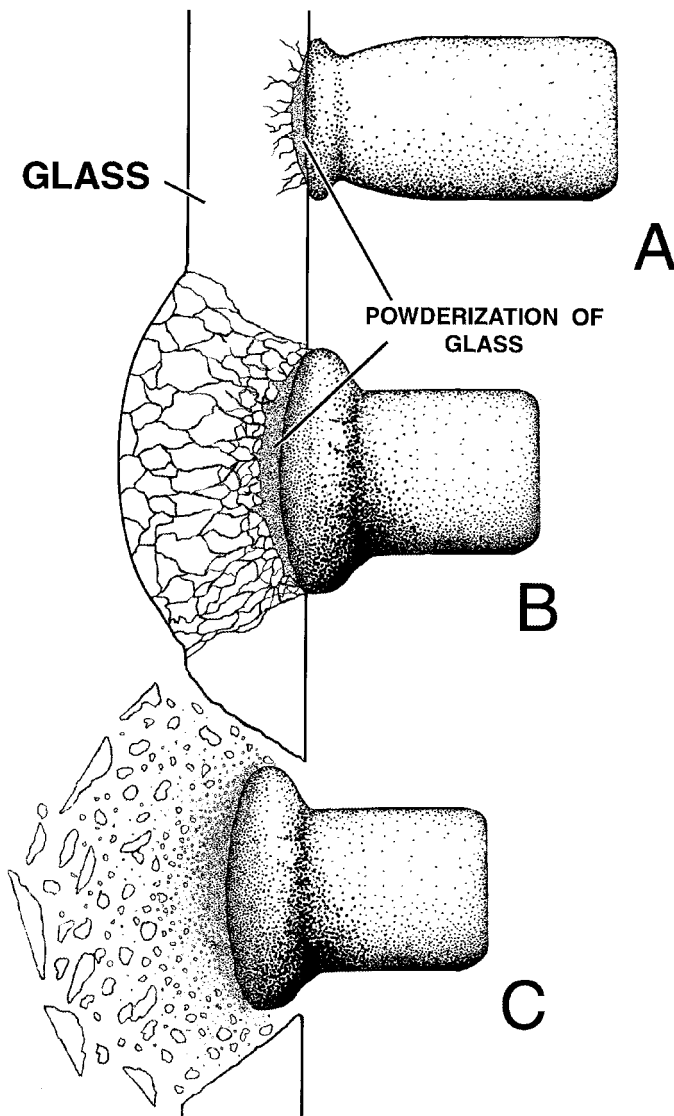
FIG. 7—Proposed sequence of events when a .22 bullet hits window glass. A: Early in the contact of the bullet with the glass. Simultaneous with the start of mushroom growth is the generation of fine glass fragments associated with the mushroom. B: The bullet at completion of mushroom formation and glass failure. C: The bullet breaking through the glass with the generation of large glass fragments. Not to scale.

A summary of the bullet interaction with window glass is given in Fig. 7. A .22 bullet is shown early in a strike on window glass in Fig. 7A. The window glass at the bullet contact does not fail immediately, but remains intact long enough for the mushroom to form. With the mushroom formation, the high pressure and temperature imparted by the bullet into the glass, powderizes the glass directly associated with the bullet mushroom. When the pressure on the glass reaches a critical point, the glass fails (Fig. 7B). The final stage is the punching of the bullet through the window with the creation of relatively large glass fragments in front of the powdered glass layer and the cone-shaped defect in the window (Fig. 7C). In this scenario, the .22 bullet does not come into contact with the large glass fragments at the time of passing through the window glass.
